Subject: Weld Sample Analysis – High Alloy

Sample Identification - Welded Educational Sample

Purchase Order Number: QC0728BH1 Project Number: P09-1407

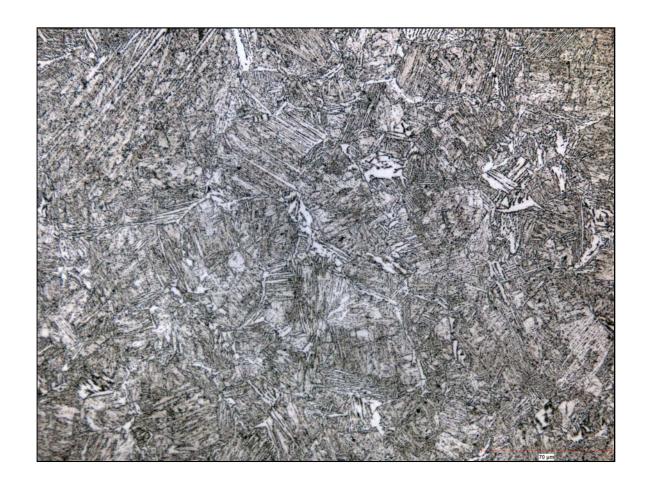
Eagle Alloy, Inc. E141Welded Educational Sample – Weld Filler Metal Image #1

A section across the weldment and into the base material was metallographically-prepared for microstructural examination. The typical structures of the weld filler, heat-affected zone in the base metal and base material away from the weldment are illustrated in Images #1 through #3.

The typical microstructure of the weld filler metal is shown.

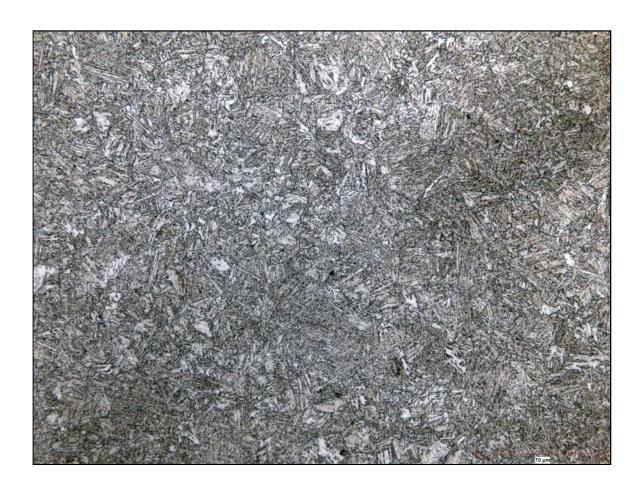
Eagle Alloy, Inc. E141Welded Educational Sample – Heat-Affected Zone Image #2

The typical microstructure of the heat-affected zone is shown.

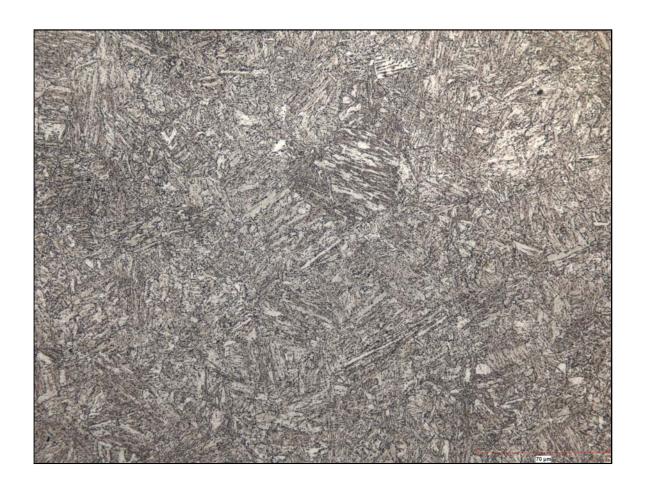
Eagle Alloy, Inc. E141Welded Educational Sample – Base Metal Image #3

The typical microstructure of the base metal away from the weldment is shown.
